<b>TITLE</b>	AX2000 Undercarriage Rotation.
<b>CLASSIFICATION</b>	This service bulletin has been classified as OPTIONAL by Cyclone Airsports.
<b>COMPLIANCE</b>	Optional.
<b>APPLICABILITY</b>	Cyclone AX2000 aircraft only.

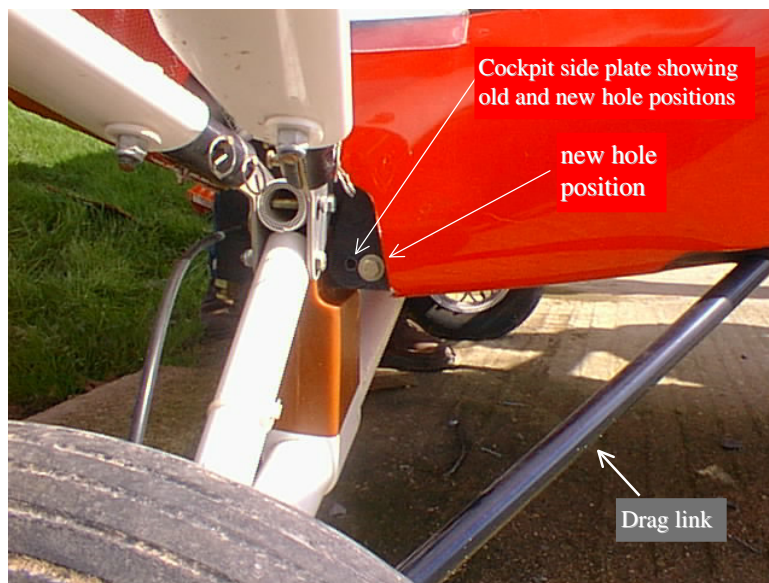
Rotation of the main axis is achieved by relocation of a hole on the cockpit side plate and shortening of the drag links. See Figure 1.

Figure 1: Photograph of AX2000 undercarriage side showing right hand drag link and cockpit side plate.

The drag links need to be shortened by 31.5mm. This alteration can be carried out on existing parts, however it is awkward and untidy. We have therefore decided to offer new drag links at a much reduced price of 50% off the normal price (no dealer margin) for a limited period of 3 months from the date of this bulletin. The part number of the new drag link is 201490.

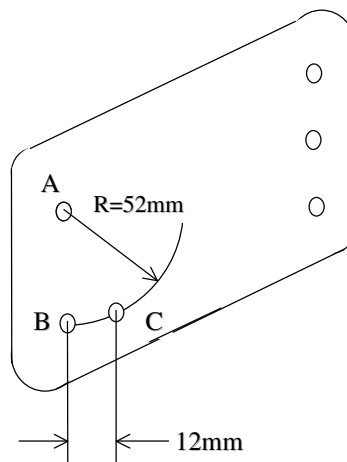
Figure 2: Modified Cockpit side plate hole configuration.

The cockpit side plate can be bought as part number ZPL-133 or modified as follows. Drill a 6.1mm diameter hole (hole C) 12mm towards the inside of the plate (from hole B) on a radius of 52mm from the center of hole A. See Figure 2.
