SERVICE BULLETIN NUMBER AX2014 **ISSUE 1** **PAGE 1 OF 1**

TITLE AX2000 power supply isolation.

APPLICABILITY All AX2000 aircraft powered by Rotax engines.

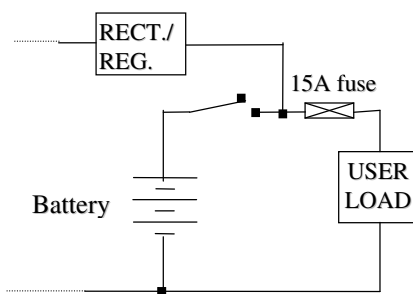
Figure 1. Wiring before modification.

A constant supply of power to aircraft starter motors and other loads with the engine running is considered to be unsatisfactory and unsafe. This bulletin details the isolation of user loads from the power supply such that there is no power to them with the master switch in the off position.
