| TITLE | AX2000 EXHAUSTSUPPORT BOLT, AX2000 TRIM TAB HORN, STEERING LINKS. |
| CLASSIFICATION | PEGASUS AVIATION CONSIDER THIS BULLETIN TO BE COMPULSORY. |
| APPLICABILITY | AX2000 |

1) EXHAUST SILENCER SUPPORT BOLT IN THE KEEL

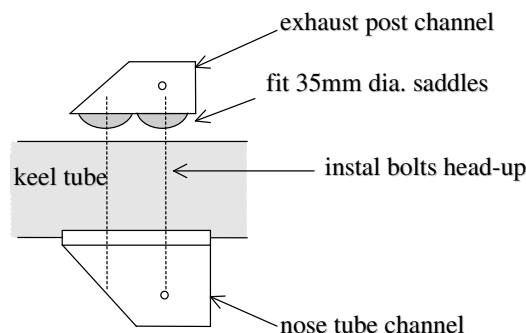
Figure 1.

The vertical bolt connecting the silencer support channel to the keel has broken on two AX2000 aircraft. The bolt is installed upside down in the original design. The saddle under the exhaust mounting channel is also of small diameter. Sideways vibration of the exhaust therefore causes leverage on the bolt threads, so the bolt fails in fatigue.

The consequences of a failed vertical bolt are that the exhaust post could possibly slide off the top of the keel, enabling the hot exhaust to contact the dacron centre section cover and possibly the battery.

Minor modification AX186 has been introduced to turn the bolt to the head-up orientation and to specify a larger diameter plastic saddle under a larger exhaust mount channel. These measures are to improve the fatigue strength, reduce the loads in the bolt and make failure at the threaded end less critical.

Remove the exhaust post from the channel and the transverse bolt from the nosewheel tube. Remove the top two ty-wraps from the windscreen. Ask an assistant to apply a downward load on the tail whilst observing the nosewheel tube. A gap will open up enabling the vertical bolt to be extracted.

The bolt should be replaced, inserted head upwards, using a larger diameter saddle and a larger exhaust channel. Tighten the M6 nyloc nut and washer, taking care not to crush the keel. The assistant should then apply an upward load on the tail, gently until the nosewheel bolt hole lines up. Replace the bolt. Replace the exhaust post and plastic washers. Replace screen ty-wraps.
