SERVICE BULLETIN NUMBER AX- 2018

TITLE	WING TIP INSPECTION and CENTRE SECTION INSPECTION.
CLASSIFICATION	CYCLONE AIRSPORTS HAVE CLASSIFIED THIS BULLETIN AS COMPULSORY.
COMPLIANCE	INSPECTION BEFORE FURTHER FLIGHT
APPLICABILITY	ALL AX-3 VARIANTS, AX2000

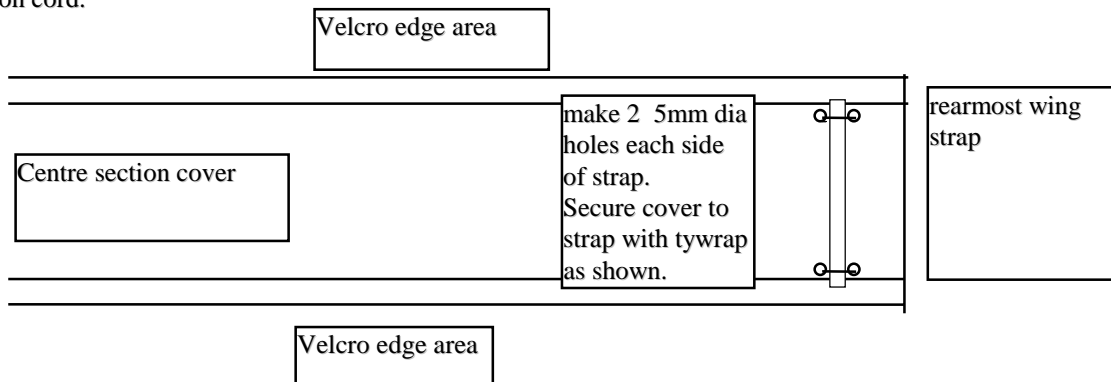
The wing centre section gap sealing cover is secured by full-length Velcro strips. Deterioration of the Velcro or insufficient pressure applied when attaching the cover, may allow it to lift at the trailing edge. If the top surface cover detaches, buffeting and partial blanketing of the tail surfaces can result. Internal pressure in the wing is also affected, which changes the aerofoil characteristics. Flight tests on an AX2000 with a panel detached to 50% chord have shown buffet felt through the elevators and rudder, with nose down trim and reduction of tail control effectiveness.

Inspect the attachment of the cover for security. Make 2 pairs of holes, each side of the rearmost wing centre section straps, with a soldering iron. Fasten the cover to the wing centre section strap using ty-wraps or 2mm nylon cord.

New gap covers are now supplied with straps to additionally secure the cover to the centre section straps (Cyclone Airports minor modification AX268).
