SERVICE BULLETIN NUMBER AX- 2018

TITLE	WING TIP INSPECTION and CENTRE SECTION INSPECTION.
CLASSIFICATION	CYCLONE AIRSPORTS HAVE CLASSIFIED THIS BULLETIN AS COMPULSORY.
COMPLIANCE	INSPECTION BEFORE FURTHER FLIGHT
APPLICABILITY	ALL AX-3 VARIANTS, AX2000

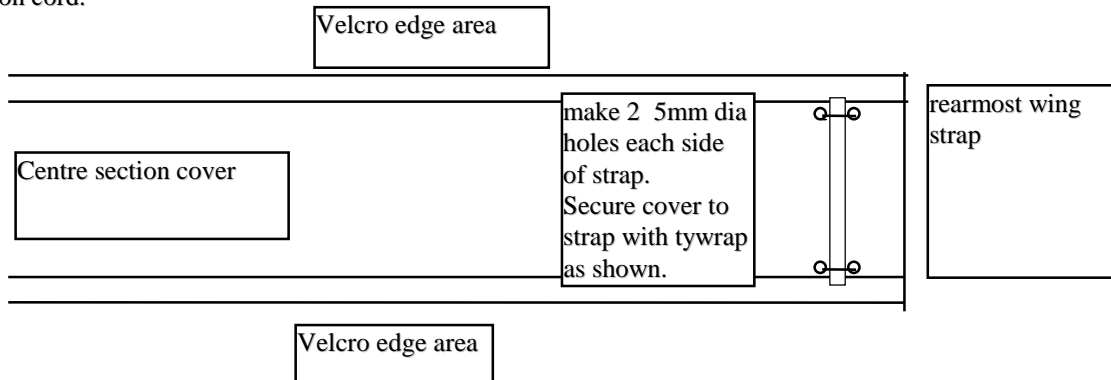
The wing centre section gap sealing cover is secured by full-length Velcro strips. Deterioration of the Velcro or insufficient pressure applied when attaching the cover, may allow it to lift at the trailing edge. If the top surface cover detaches, buffeting and partial blanketing of the tail surfaces can result. Internal pressure in the wing is also affected, which changes the aerofoil characteristics. Flight tests on an AX2000 with a panel detached to 50% chord have shown buffet felt through the elevators and rudder, with nose down trim and reduction of tail control effectiveness.

Inspect the attachment of the cover for security. Make 2 pairs of holes, each side of the rearmost wing centre section straps, with a soldering iron. Fasten the cover to the wing centre section strap using ty-wraps or 2mm nylon cord.

New gap covers are now supplied with straps to additionally secure the cover to the centre section straps (Cyclone Airsports minor modification AX268).
